9 ROXBURY ROAD SCARSDALE, NEW YORK

Tech Notes

NUMBER 19

Repairing Steel Casement Windows

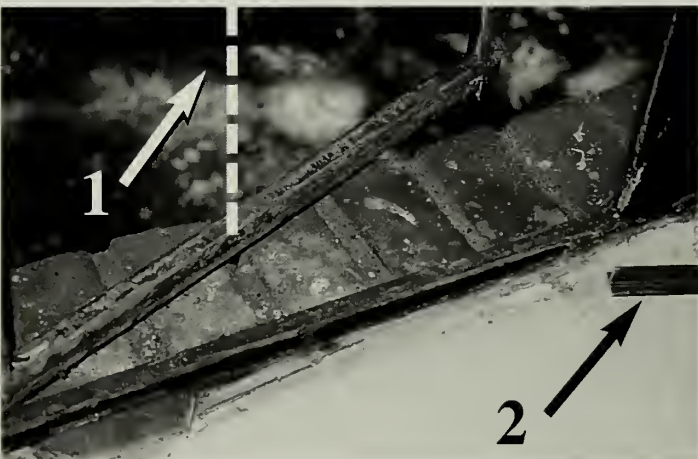
The windows on 9 Roxbury Road showed deterioration and damage typical of historic steel casements. In the course of over seventy-five years, corrosion, wear and some distortion of the sash and frame had occurred. Rust was particularly prevalent along the lower parts of the sash and frame where water had penetrated the distorted opening and the cracked perimeter

caulk (see figure 4). Originally tight fitting, all of the sash were bent out of alignment with resulting gaps from 1/16" inch to 3/4" inch between sash and frame. Hardware was corroded, stiff, and in some windows, seized shut. Prior attempts to force the distorted windows closed had also bent some of the locking handles and other hardware.

Figure 4. The sash and frame were most severely corroded along lower, horizontal members. A vertical glazing bar had previously been removed from the sash above to fit a window air conditioning unit (1). A replacement "T"-shaped length of steel that will be spliced in can be seen on the right (2).

In order to repair the four windows previously altered for air conditioning at 9 Roxbury Road, it was necessary to replace missing metal sections along the lower third of the sash and frame. Lengths of replacement steel with the typical “Z” and “T”- shaped profiles were obtained from a stock of salvage material maintained by the repair company. Exact matches were easily achieved because replacement pieces came from identical Fenestra casement windows of the same period. To rebuild the sash, replacement steel bars were held to the existing sash with clamps and brazed together with an oxygen-acetylene torch (see figure 7). After

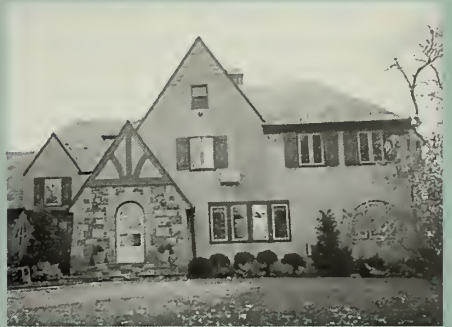
Inappropriate replacement windows dramatically affect the appearance of a historic home that once featured steel casement windows.

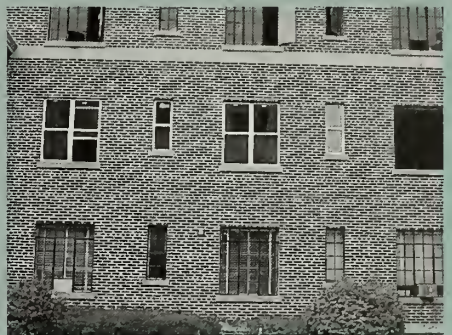
Historic steel casement windows are in the process of being replaced with new units that compromise the character of this building facade.

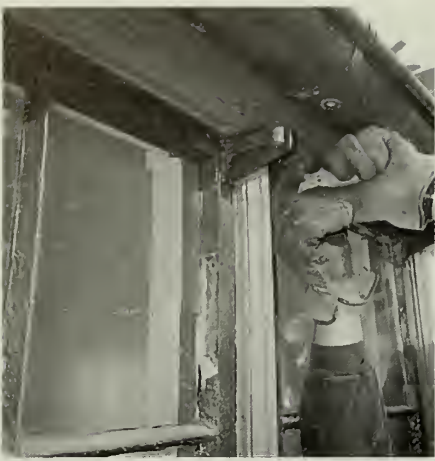
Figure 5. Before realigning the window, paint, caulk, weatherstripping and rust were stripped from all surfaces where the sash and frame were in contact.

After protecting the work area, layers of paint, rust, caulk and weatherstripping were scraped from all contact surfaces where the sash meets the frame and where locking pieces meet (see figure 5). Such extraneous material had to be removed before attempting to realign the window, so that the severity of distortion could be accu-

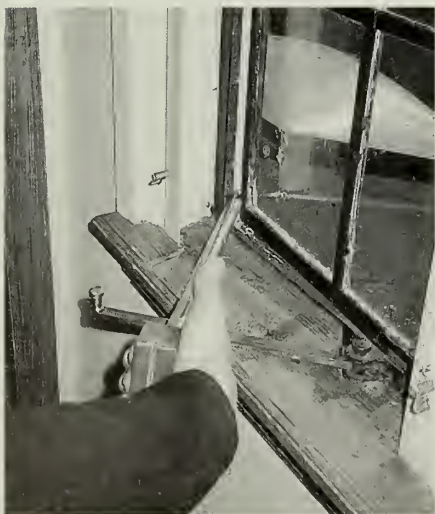
Figure 6. Pull bars were used to realign the sash from the inside. These custom made tools were especially useful on single sash units where the worker was unable to reach through an adjacent opening to apply pressure from the outside.

ately determined and the repairman could tell when a correct fit was achieved. Using metal shims of varying thickness placed between sash and frame, the worker then began the realignment process by gently applying pressure to the sash. With the shims acting as levers, one location was pushed in while another was pulled, to bring racked corners and warped planes back into alignment. Where the sash was bent outward on either the top or bottom, it was gently twisted back into shape. On single windows, where there was little room to reach out and manipulate the sash from the inside, various pull bars custom-made of notched aluminum rods were used (see figure 6). When the sash was aligned, bent locking pieces and other hardware were similarly returned to their original shape or, where broken, replaced with identical pieces.

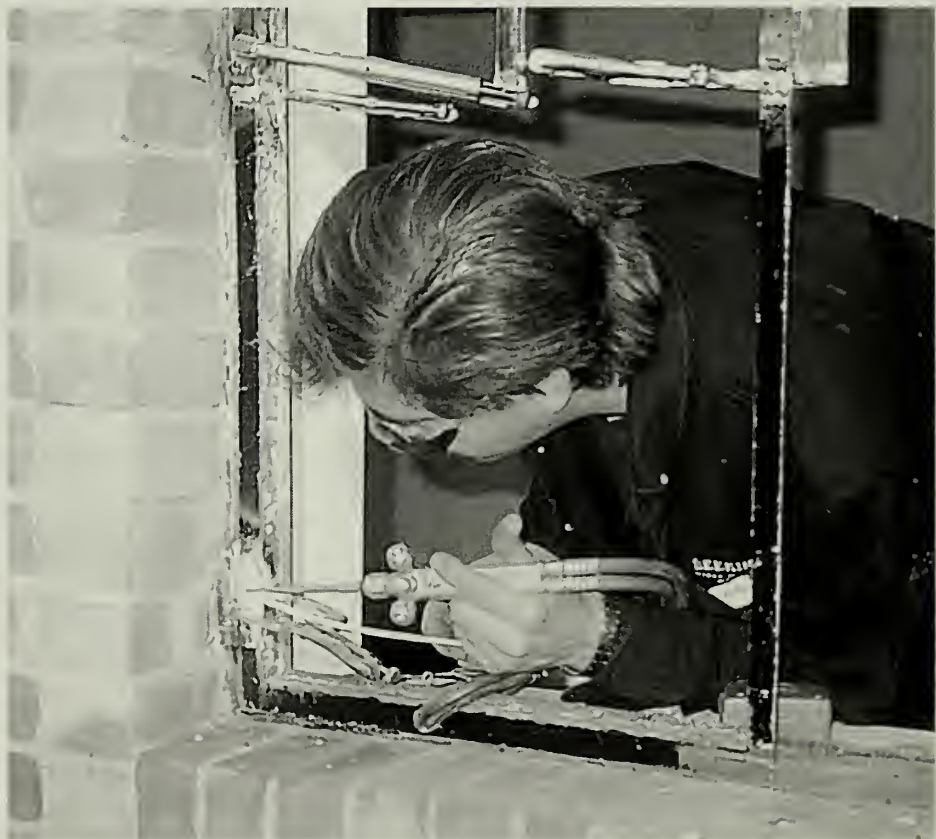
Figure 7. New steel sections were brazed into the historic sash and frame where the windows had previously been altered to fit air conditioning units. Because the replacement pieces came from a stock of salvaged window materials, they matched perfectly the profiles and dimensions of the missing sections.

cooling, the brass seam was ground down with a sander so that it was flush with the existing surface. Though not necessary in this project, a similar treatment can be used when portions of the frame or sash are corroded beyond repair. In such a case, damage is usually limited to the frame, sill and lower portions of the sash, where unattended water problems lead to severe oxidation. The deteriorated section can usually be cut out and new pieces from salvaged stock brazed into place.

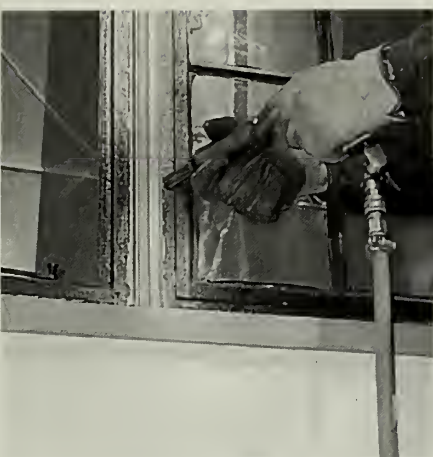
Figure 8. A pneumatic needle gun was used to strip much of the paint from the steel frame and sash. It was followed by wire wheel and small disk sanders and hand chisels. The blunt tipped needles did not damage the steel or adjacent glass.

Initial paint and rust removal was done with a pneumatic needlegun. When set to a standard air pressure, the needlegun neither pitted the steel, nor damaged adjacent glass (see figure 8). Occasionally an air hammer with a blunt end attachment was also used. The needlegun was followed by a sander with wire wheel attachments. Run the length of each steel member, this tool removed almost all of the remaining paint and most of the rust. It was especially useful in clearing pockets of rust from crevices and gently grinding down the more severely pitted surfaces. Removing rust with a sander was preferred over sandblasting because a sander is less messy, does not require shielding the glass and masonry surround, and is less likely to damage the steel. Finally, a small hand chisel and sandpaper were used in corners, on the inside edges of the hinges and in other tight locations not reachable with larger tools. Because they were used as guides for the application of the new putty bevel, it was essential that the edges of the muntins were free from nicks or bumps that would have resulted in an uneven profile.

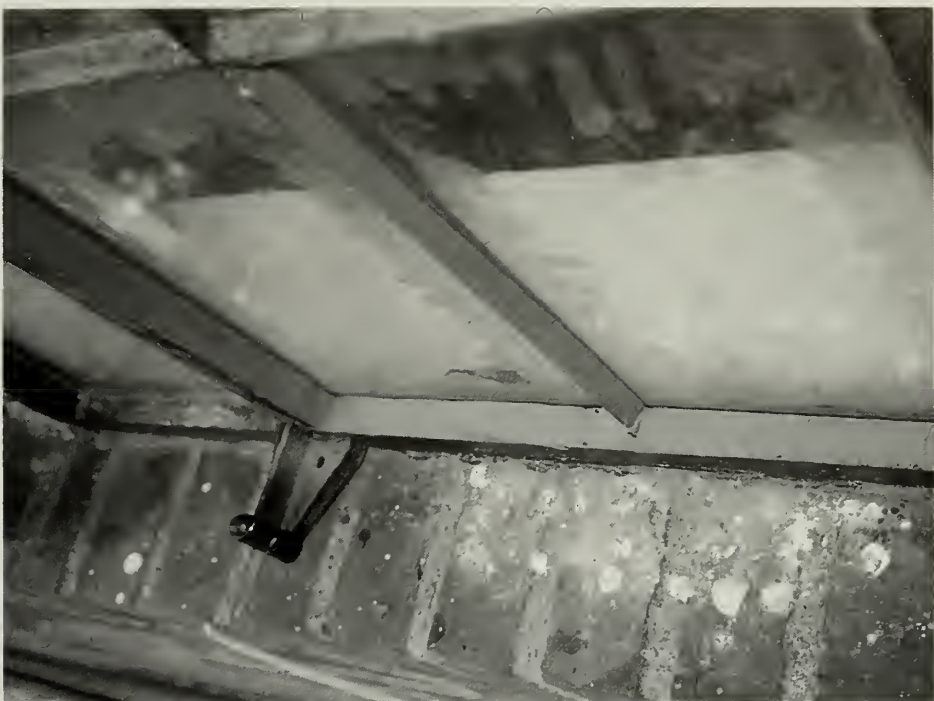
Figure 9. An oil-based putty was used to reglaze the historic casement windows. Painting was undertaken two weeks after reglazing.

The glazing contractor used natural, oil-based (linseed or soybean) putty that remains relatively soft. Putty was repacked along the interior face first. In keeping with the historic appearance of the windows, all putty lines on the inside were run flush with the muntin, so that no bevel profile was present. This brought sightlines back to the narrow appearance that is so characteristic of historic steel windows, while creating a watertight seal that keeps condensation from entering the joint. Putty was then applied along the exterior in a beveled profile that helps shed water (see figure 9). Finally, the glass was carefully cleaned with a four-inch razor blade followed by a standard glass cleaner.

Although the manufacturer states that the putty can be painted the day after application, the painting contractor preferred to allow two weeks for the putty to cure sufficiently. Two finish coats were applied to the frame, sash and glazing putty. The industrial paint, a brand commonly used on steel bridges, was custom mixed a taupe color to match the exterior wood trim. To form a moisture resistant seal, paint was extended a small amount beyond the putty and onto the glass face – a standard practice, both past and present.

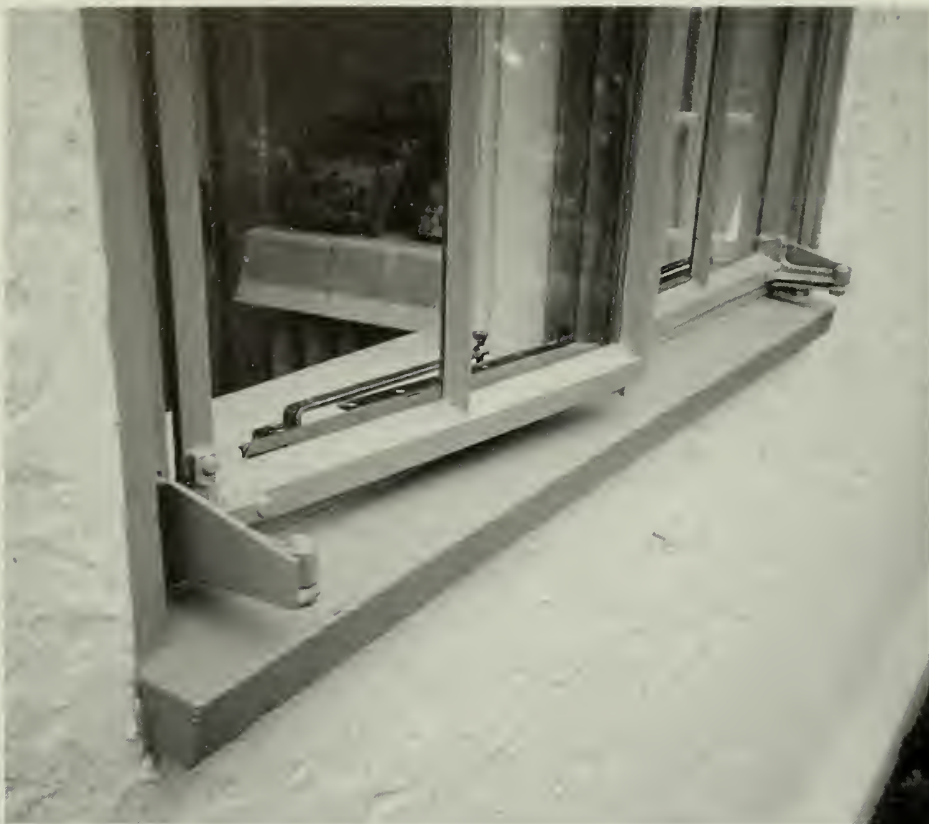
Figure 10. Detail of complete windows, repaired, serviced, reglazed and repainted.

Repairing the historic steel casement windows at 9 Roxbury Street preserved a significant feature of the house, one that is important to the exterior appearance as well as the interior. With the removal of deteriorated paint and putty and a return to original narrow sight-lines, the historic look of the windows was enhanced rather than diminished (see figures 10 and 11). Window perfor-

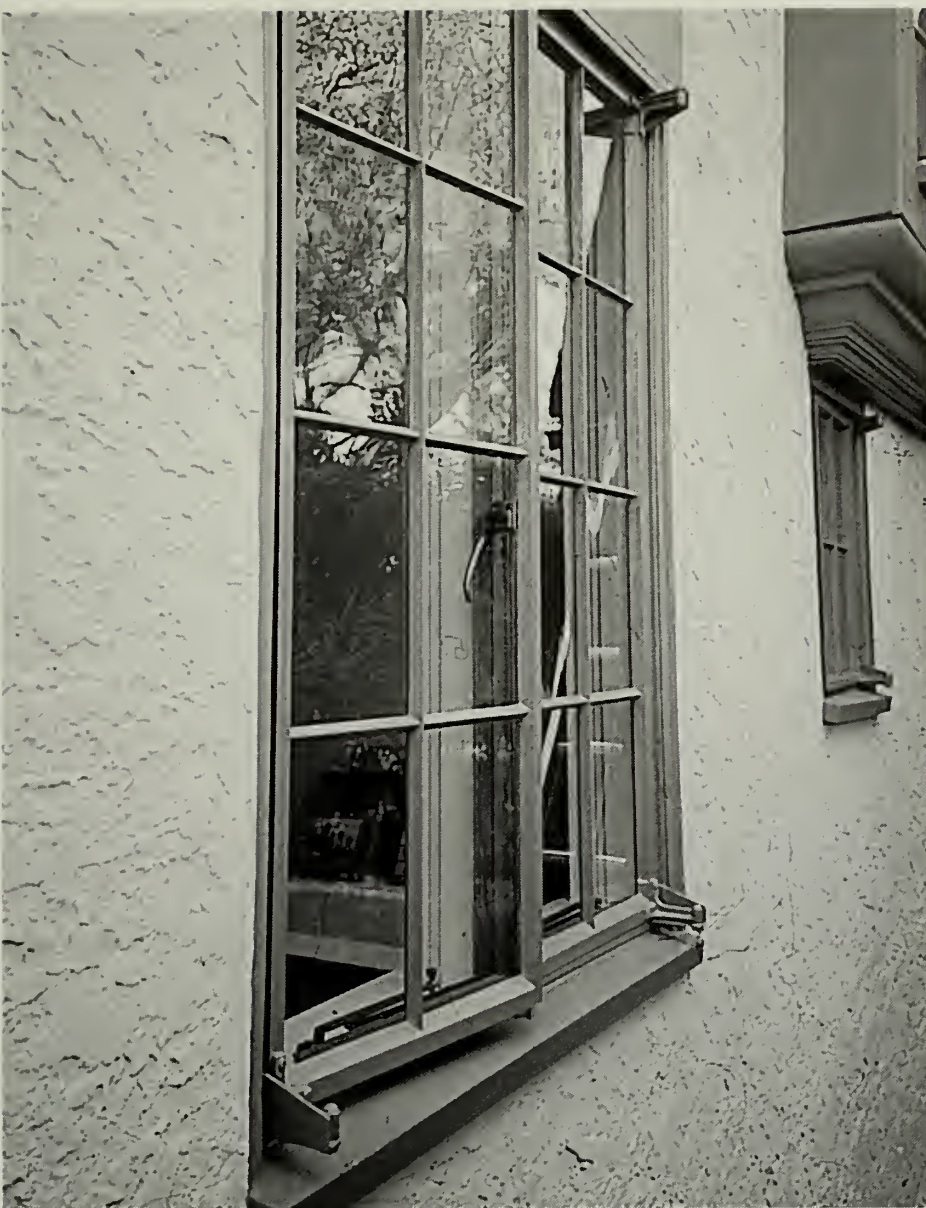
Figure 11. The completed work reveals the aesthetic appeal of the historic casement window – qualities appreciated both past and present.
